«The Extension of the Quay of the German Wharf - 100 Years After. Version 1.1. E

A distilled audiovisual presentation
of an archival study

by
Arne Skivenes,
for
UNESCO Advisory Mission.
19.september 2022

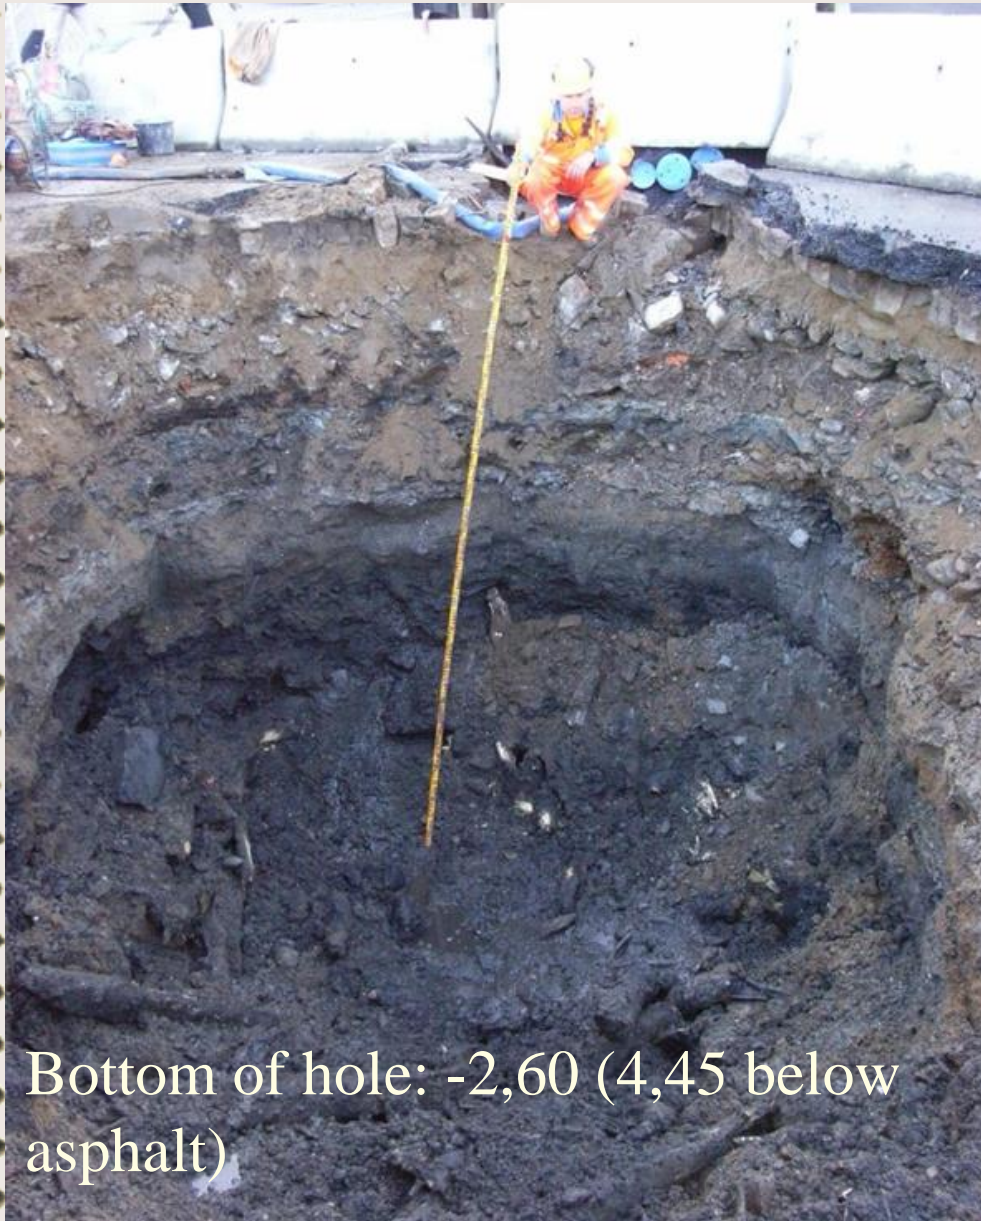
Test core MB12, 2008

Front Holmedalsgården, 2007

Bottom of hole: -2,60 (4,45 below asphalt)

01-03: +1,15—1,45

Soil, gravel, mixed with red brick material, charred wood, rotten pieces of wood

04 -1,45 - -1,75:

Half rotten timber (bulwarks?) strong stench from H₂S, decomposition

10 - 7,60- -8,25:

Cultural layers carbondated to year 1150-1220.

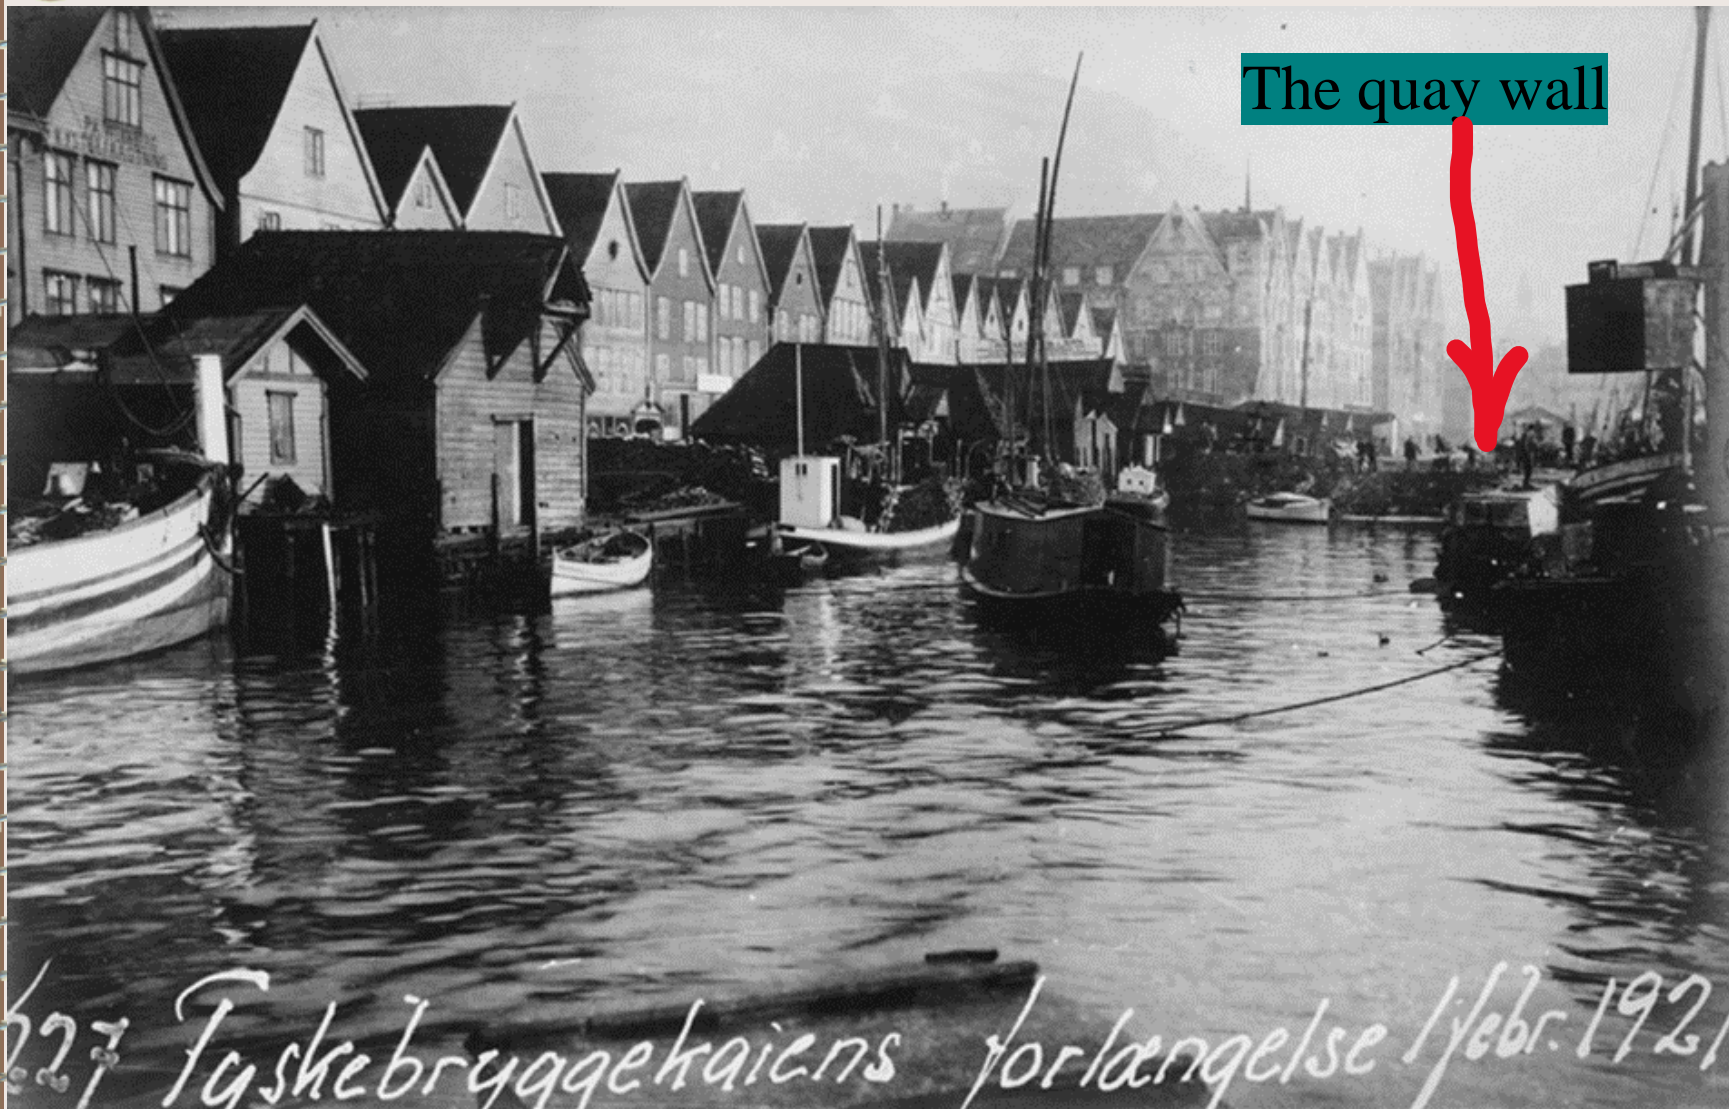
227 Taskebruggkaiens forlængelse 1/febr. 1921

The quay wall

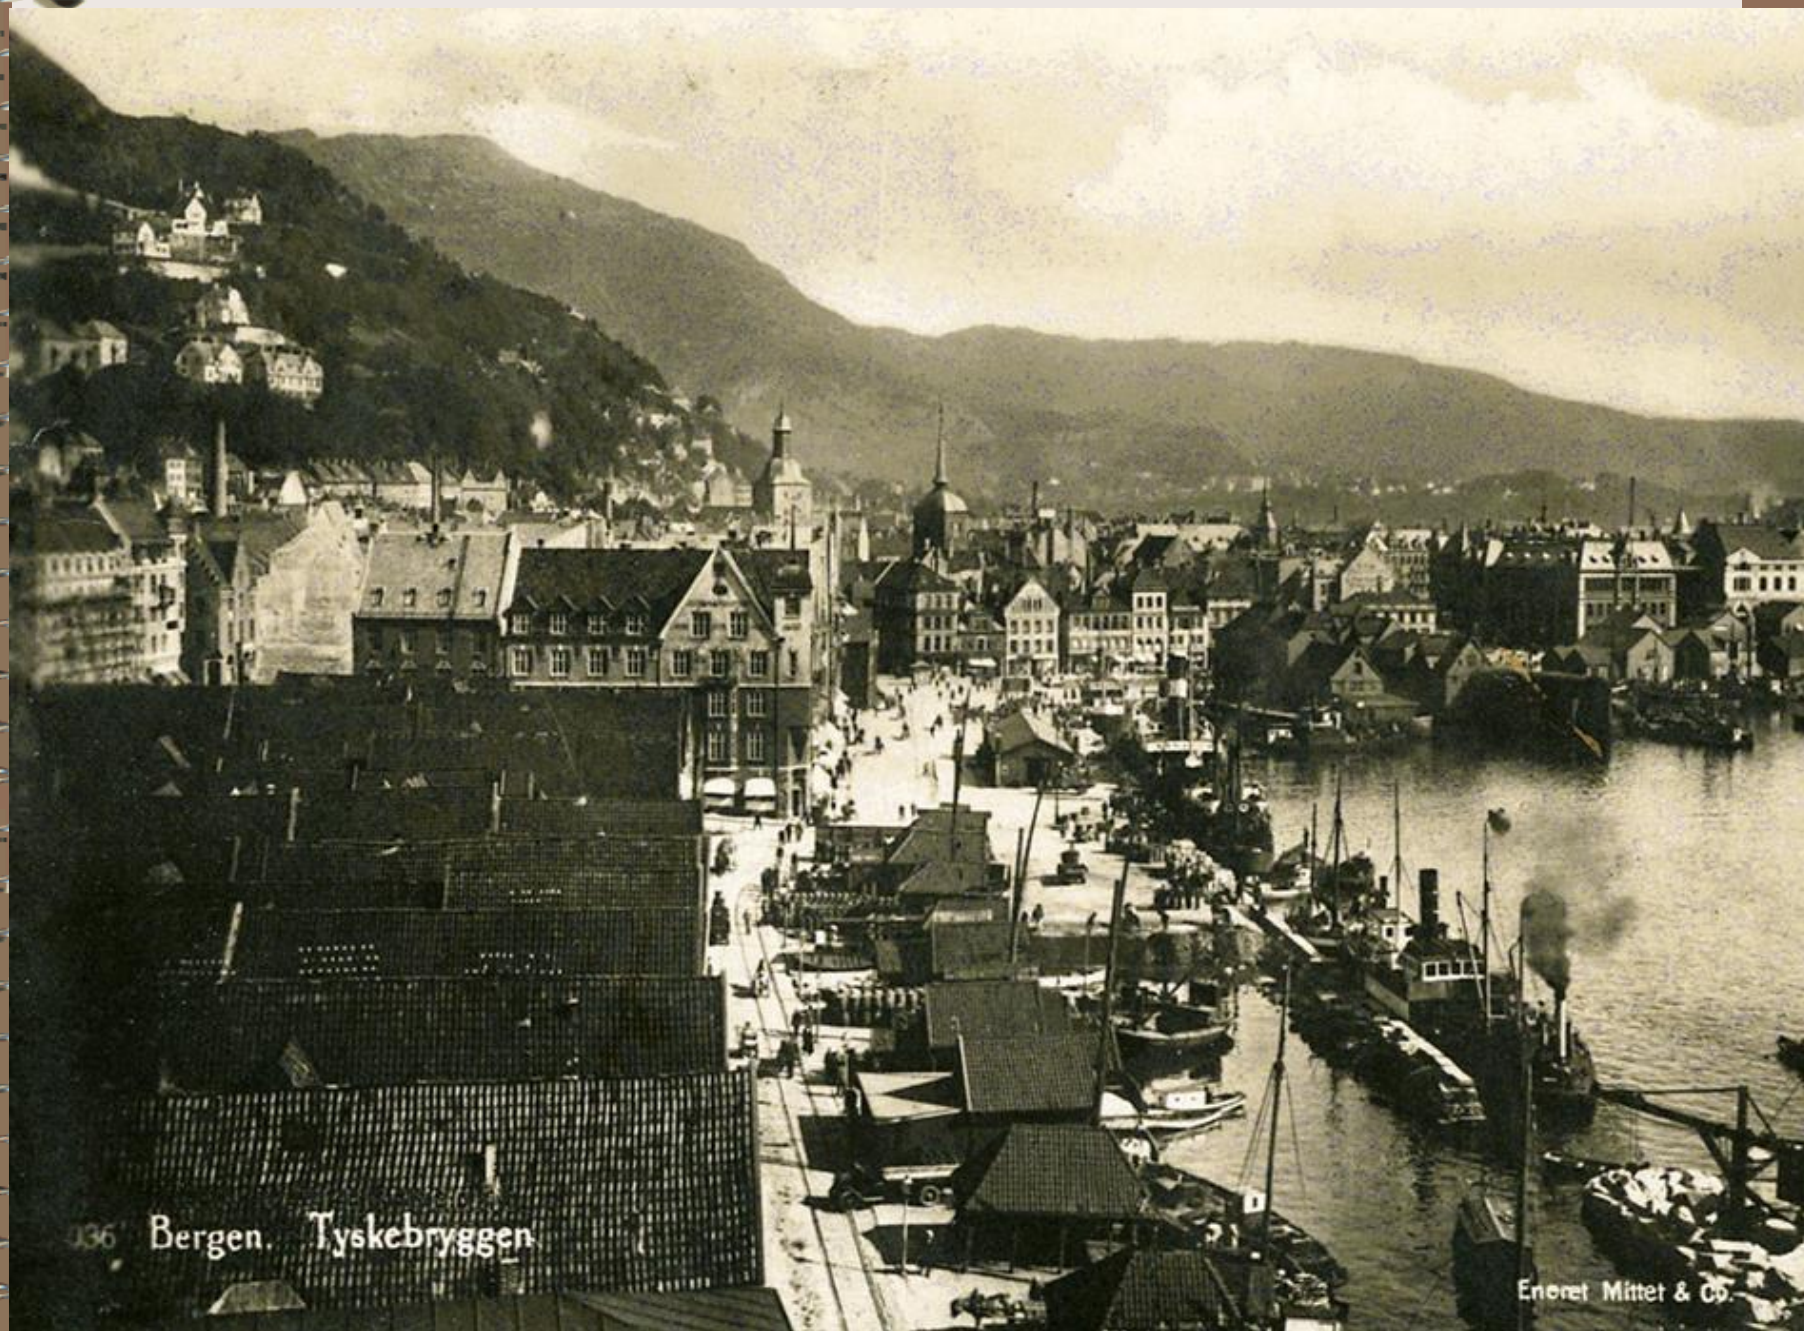
036 Bergen. Tyskebryggen

The outer quay wall

- 23. jan. 1919 first boulders visible above surface
- 1.march 1919 50 m quay length finished. Some filling on inside, but not the innermost 10 metres. Owners complain: shallow and difficult access. Further construction delayed for almost a year
- 16. april 1920 80 m laid. Backfilling can start.
- 22. sept. 1920 110 m finished
- 15. jan. 1921 156 m laid, 2/3 of the length filled
- 22. feb. 1921 160 m masonry work finished

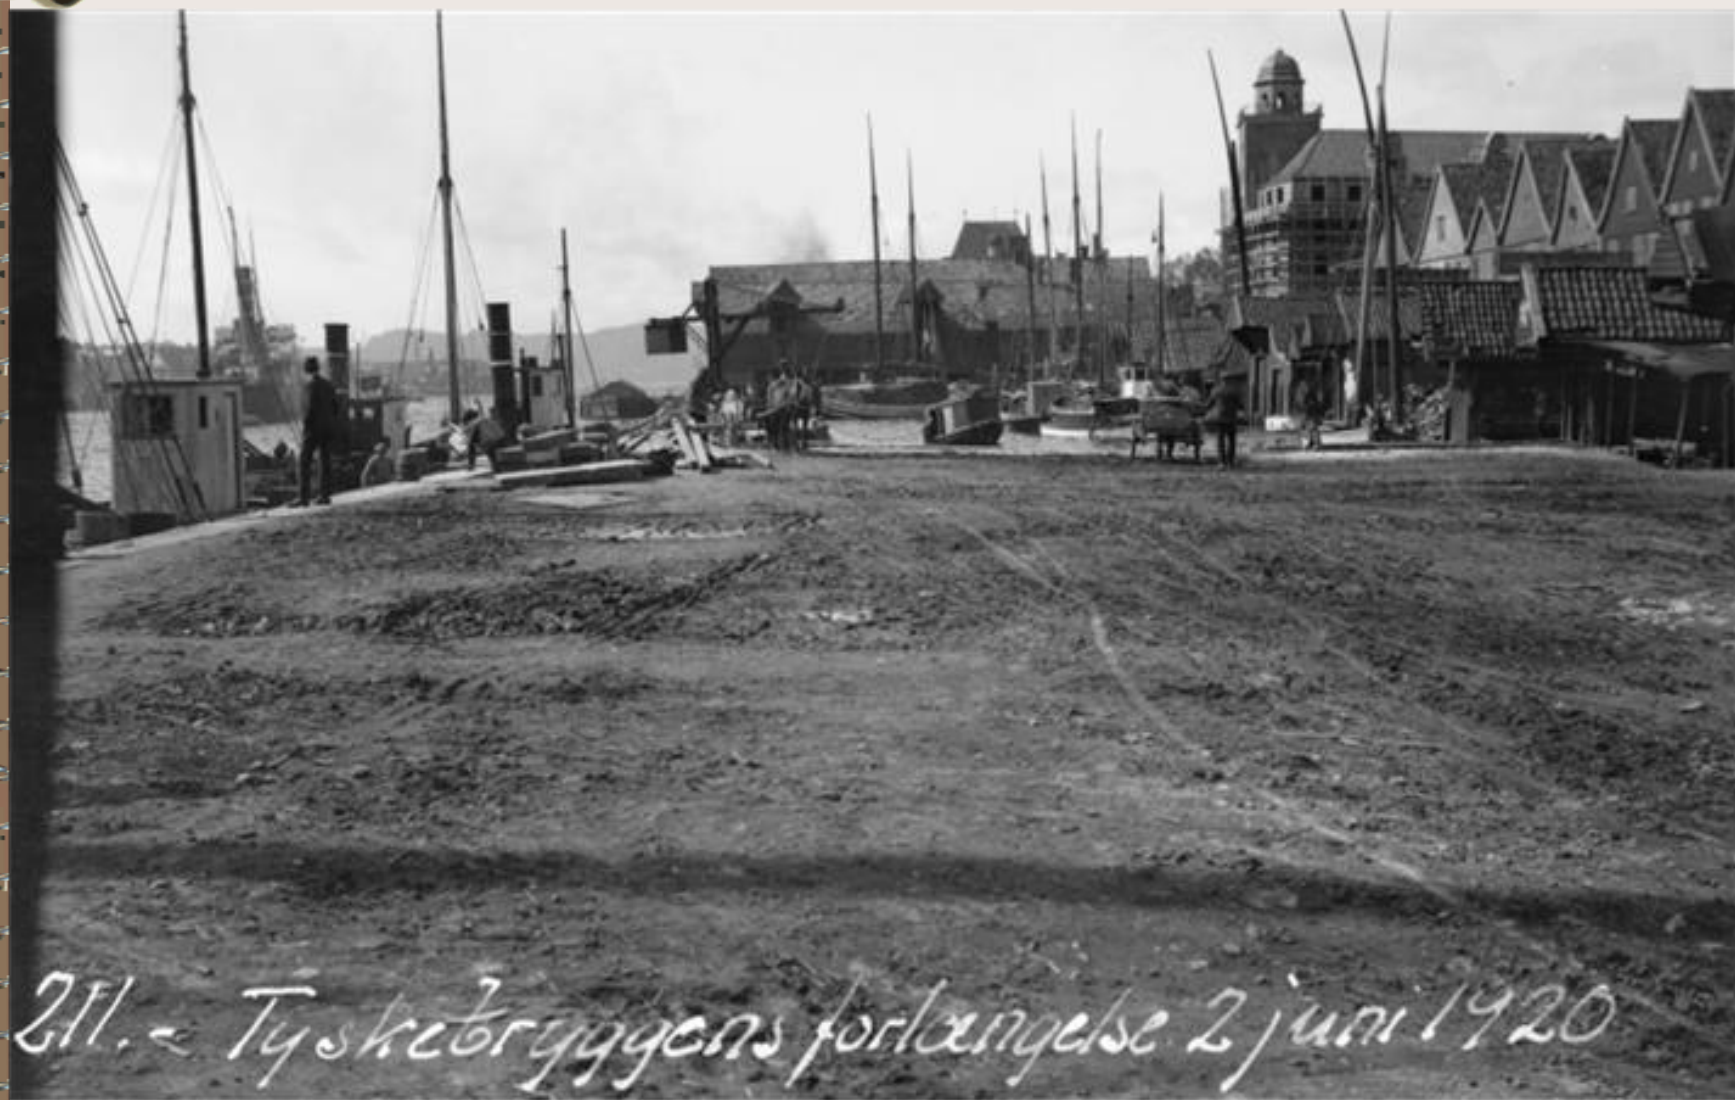
211. - Tyskebruggens forlængelse 2 juni 1920

Filling compounds

- Function:
 - Stone fill (jeté) – Back fill
- Where did the materials come from?
- When are they available?
- What did they consist of?
- Are they stable?
- Do they have any historical value?

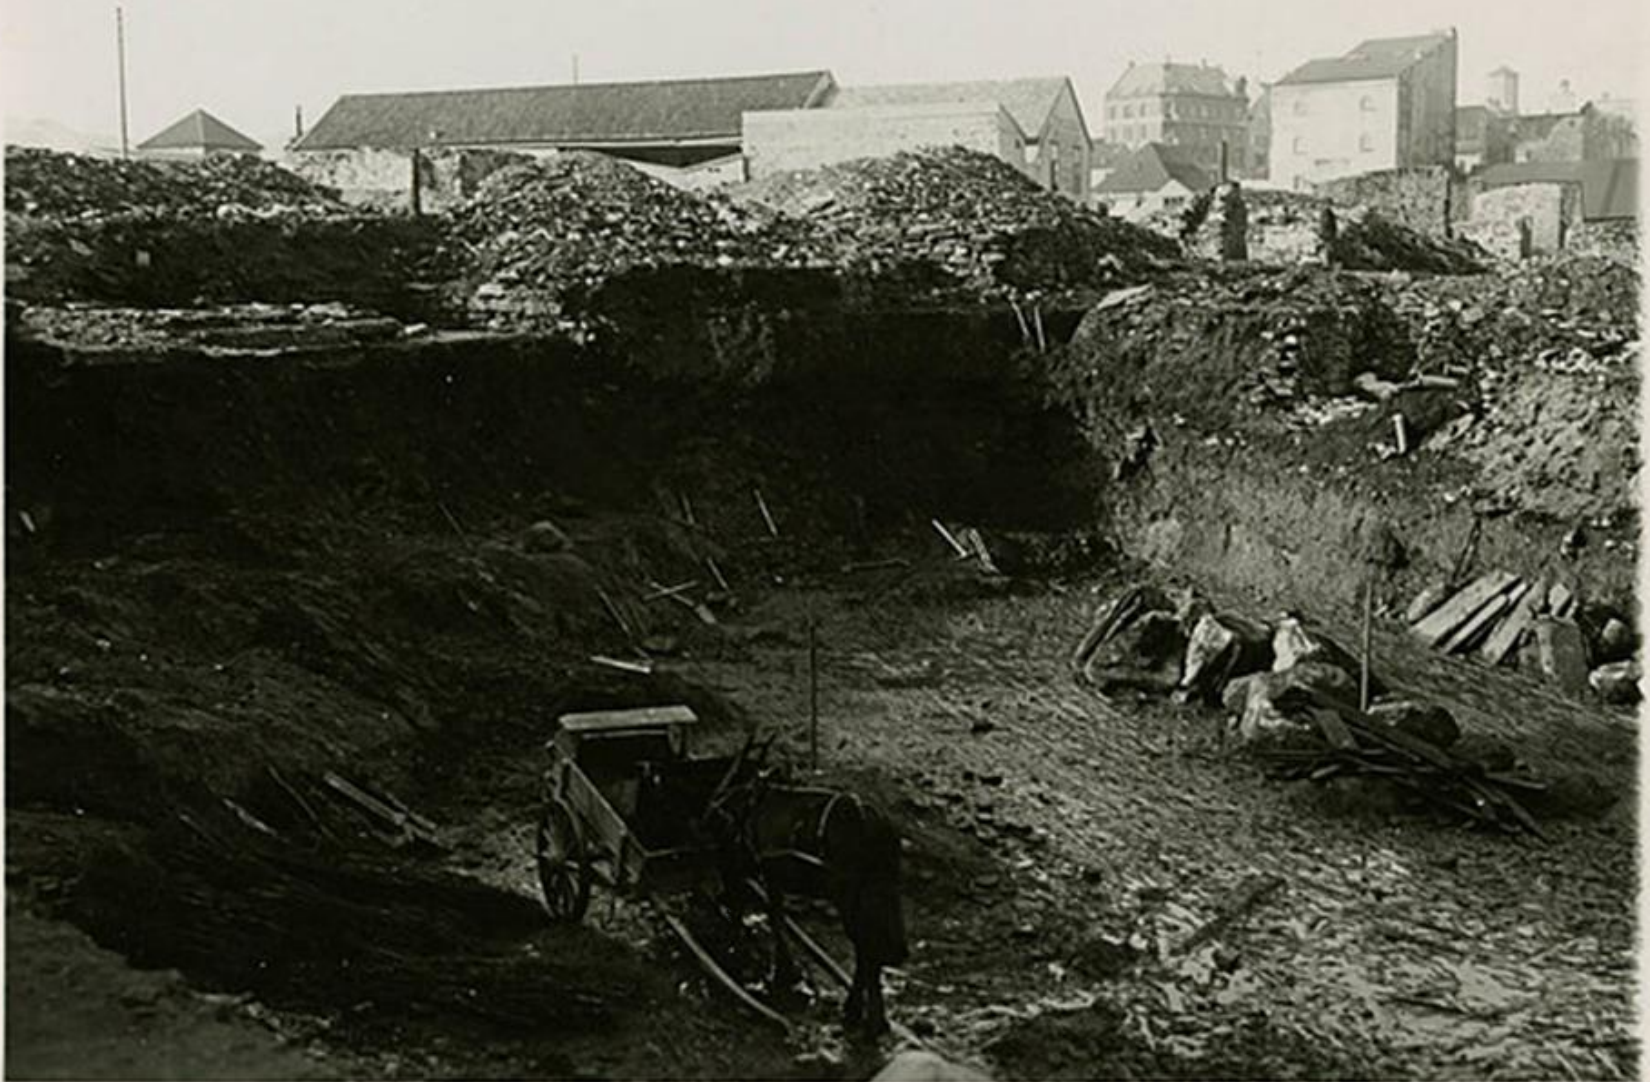
The fire site 1920. Site for Post office / Exhibition

- Not from stone quarries near Bergen
 - Reason why: too expensive
 - Proof: Ledgers show: no such transactions made
- Mainly from the clean-up of the fire site from 1916.
 - Cheap (free!)
 - proximity
 - The fire site had to be emptied of masses, estimated 146.000 m³

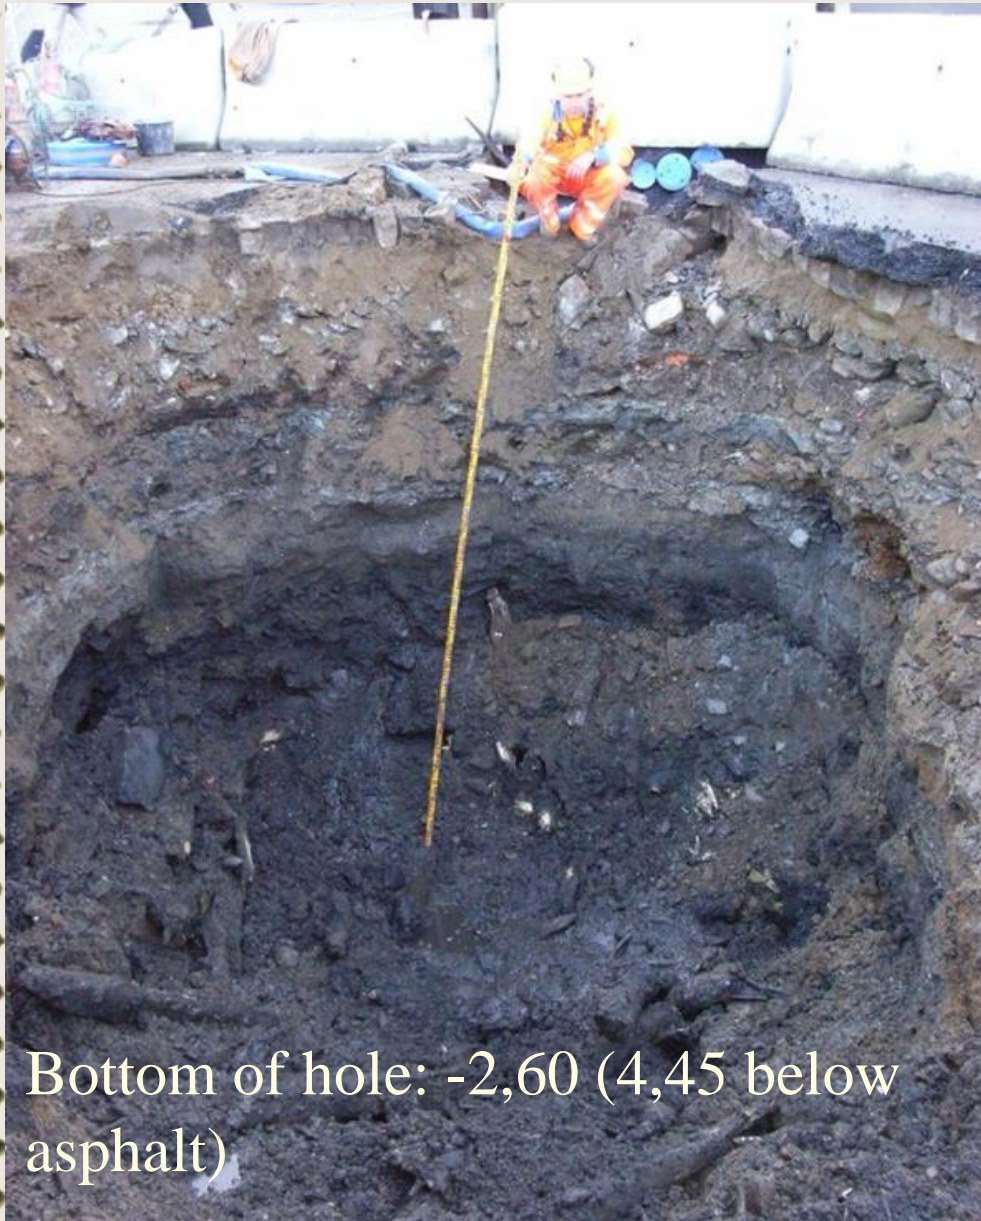
Test core MB12, 2008

Front Holmedalsgården, 2007

Bottom of hole: -2,60 (4,45 below asphalt)

01-03: +1,15—1,45

Soil, gravel, mixed with red brick material, charred wood, rotten pieces of wood

04 -1,45 - -1,75:

Half rotten timber (bulwarks?) strong stench from H₂S, decomposition

10 - 7,60- -8,25:

Cultural layers carbondated to year 1150-1220.
